Preliminary Assessment
Big River Mine Tailings
Desloge, St Francois County, Missouri
TDD #F-07-8711-039 PAN #FM00616PA
Site #Y60 Project #001
Submitted to Paul E Doherty, RPO
Task Leader Robert Overfelt, E & E/FIT
Superfund Contact Gene Gunn
Date May 17, 1988

TABLE OF CONTENTS

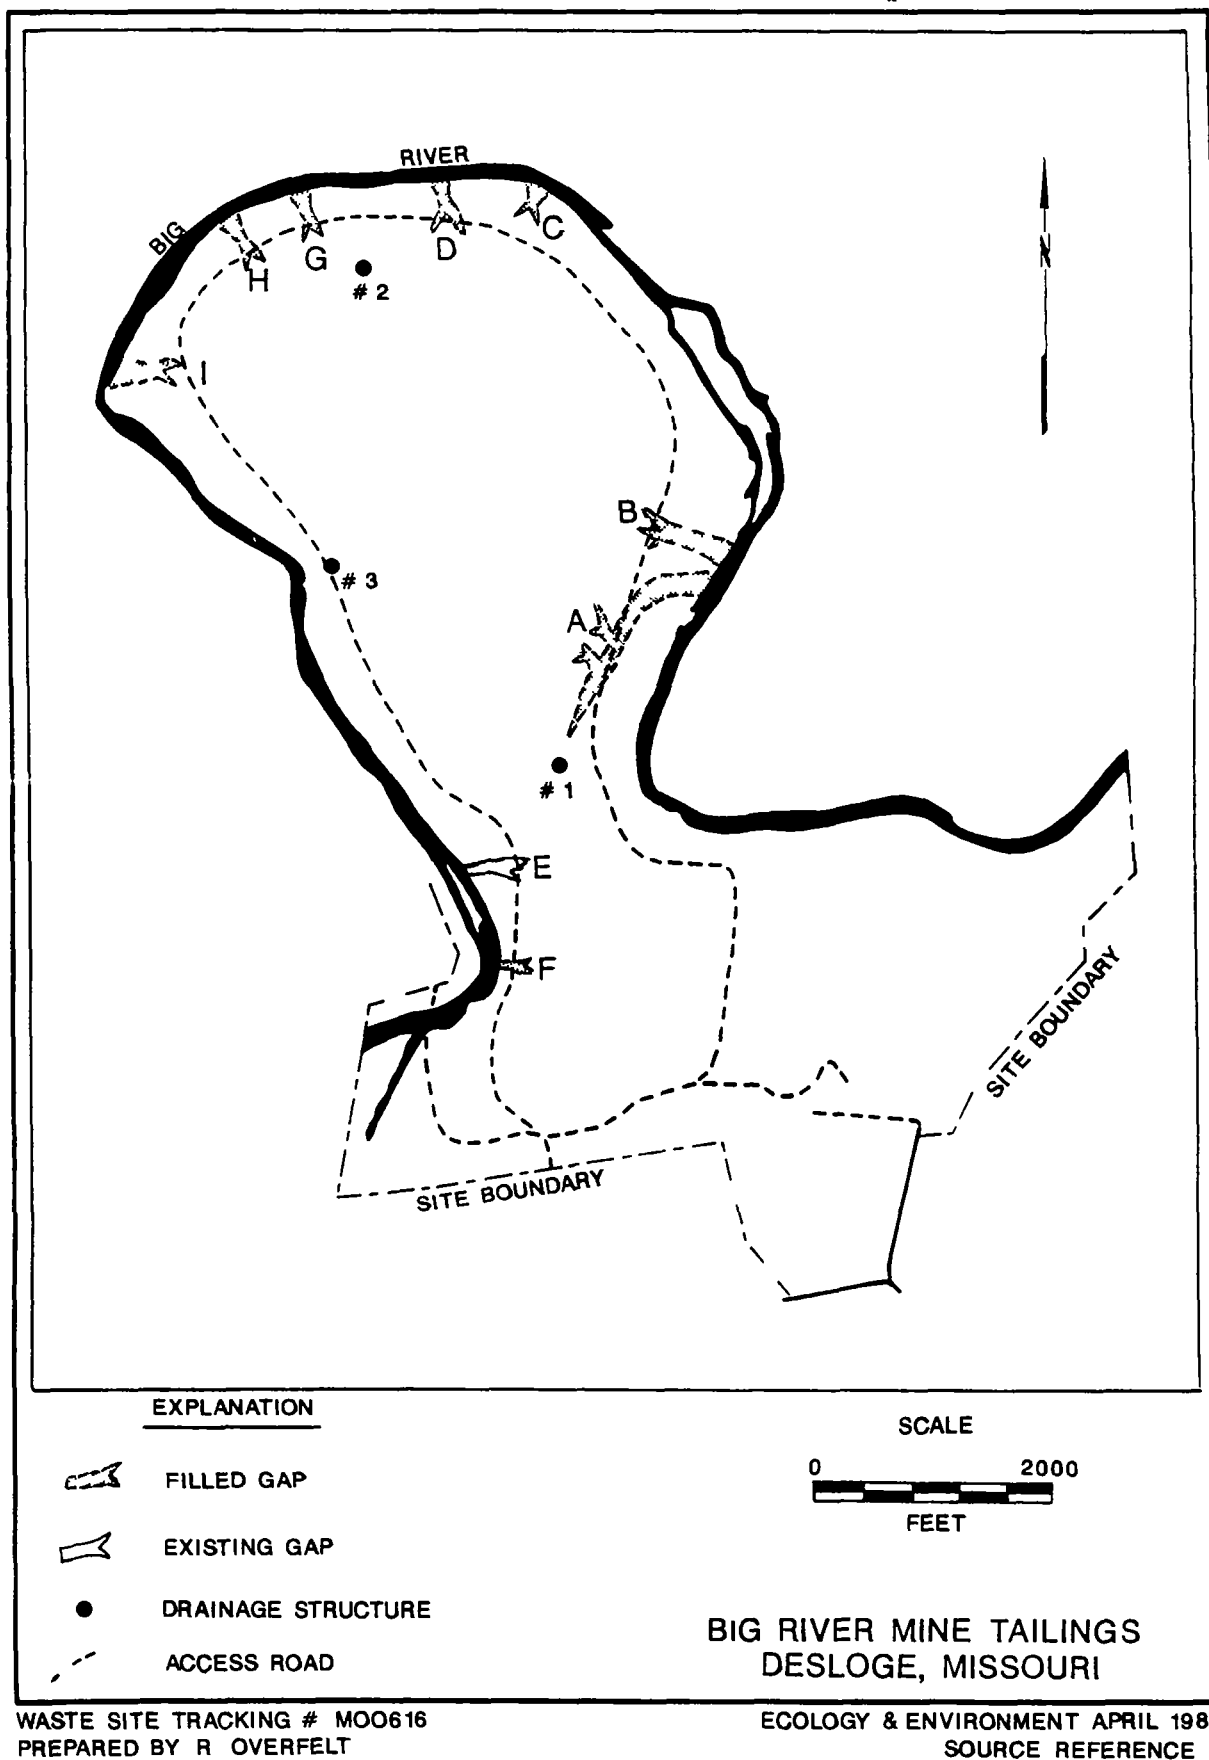
FIGURE 3 MAJOR EROSIONAL FEATURES

A comprehensive report prepared in 1980 for MDNR by the University of Missouri-Columbia (UMC) College of Engineering characterizes the major environmental concerns at the site including water and wind erosion and the apparent hazard of constructing a landfill in the tailings pile. The UMC investigation concluded that the tailings pile contained numerous points where tailings are entering the Big River due to water erosion. The UMC team designated six gaps, which were labeled alphabetically around the pile starting on the southeast side (Figure 3). Erosional gaps G, H, and I developed after the report was completed and have been labeled as they occurred.

The original drainage structures placed by the mining company are illustrated in Photo C-14 (Appendix D). These concrete drainage structures were constructed to drain the water from off the tailings pile. During the E & E/FIT site reconnaissance, it was noted that drainage structure #1 near Gap A was totally collapsed and was no longer functional. According to the UMC report, drainage structure #1 became blocked and this blockage led to the massive erosion which occurred in 1977 at Gaps A and B. The UMC report recommended that the major erosional gaps be filled with a suitable fill material and the area reshaped to reduce further erosion. Further, the report suggested that the drainage structure located near Gap A be altered to minimize the chance for overflow (Ref. 4).

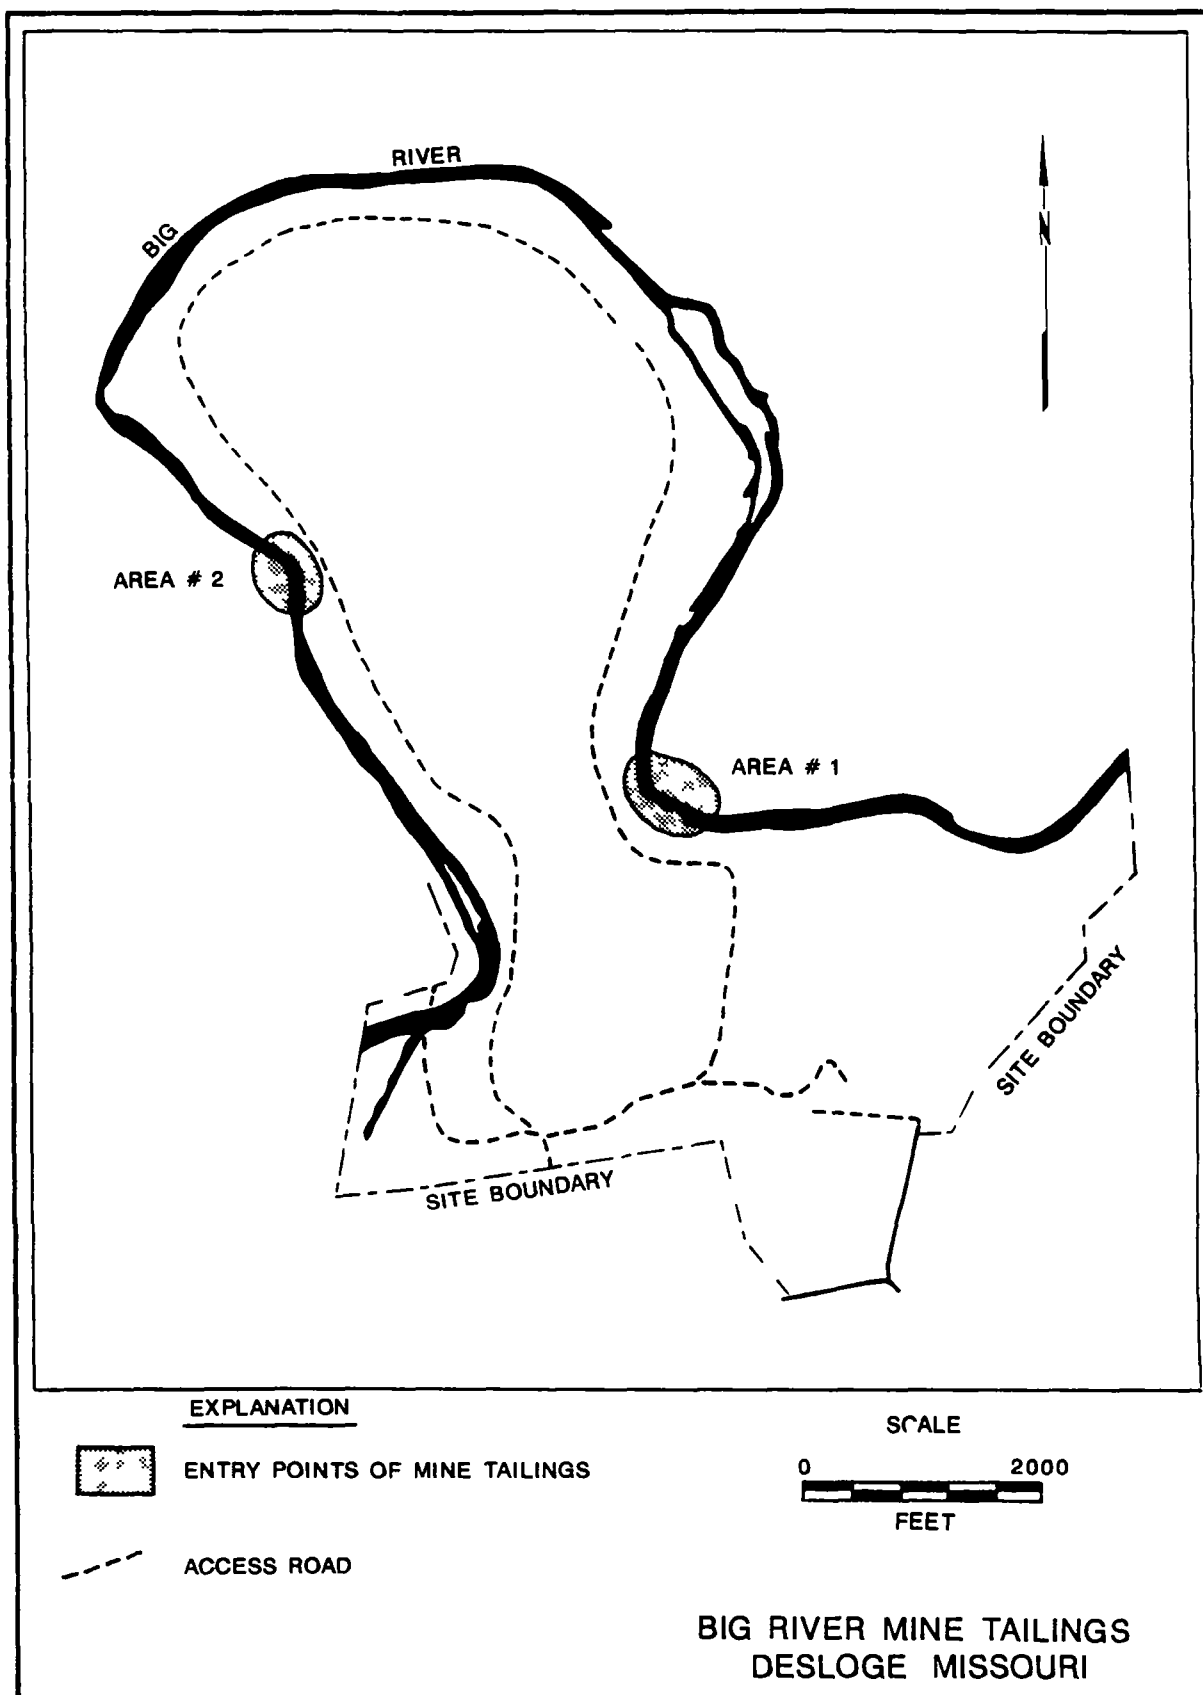
FIGURE 4 OBSERVED ENTRY POINTS OF MINE TAILINGS TO BIG RIVER

Wind erosion and the associated blowing of lead-laden dust is also a major concern (Appendix D, Photo C-1). There the tailings pile reaches the river bank in two areas (Figure 4). During the FIT reconnaissance, it was noted in areas #1 and #2 that the wind was eroding the tailings over the steep incline. As tailings accumulate, and their angle of repose is exceeded, they collapse and fall into the river (Photo C-2). The major problem at area #2 is the river undercutting the bank, which eventually could lead to a collapse of the tailings in the area into the river (Photos C-12, C-13). Wind erosion is generally from west to east, which produces a continuous movement of the tailings toward the east. Because the tailings are a very fine, dolomitic sand or silt, sufficient wind velocity creates a tailings dust cloud. During the site reconnaissance this occurrence was observed to be a serious problem (Photo C-1). A dust plume originating from the site was transporting dust at least one mile to the southeast. Wind speeds on that day included gusts up to 35 miles per hour.

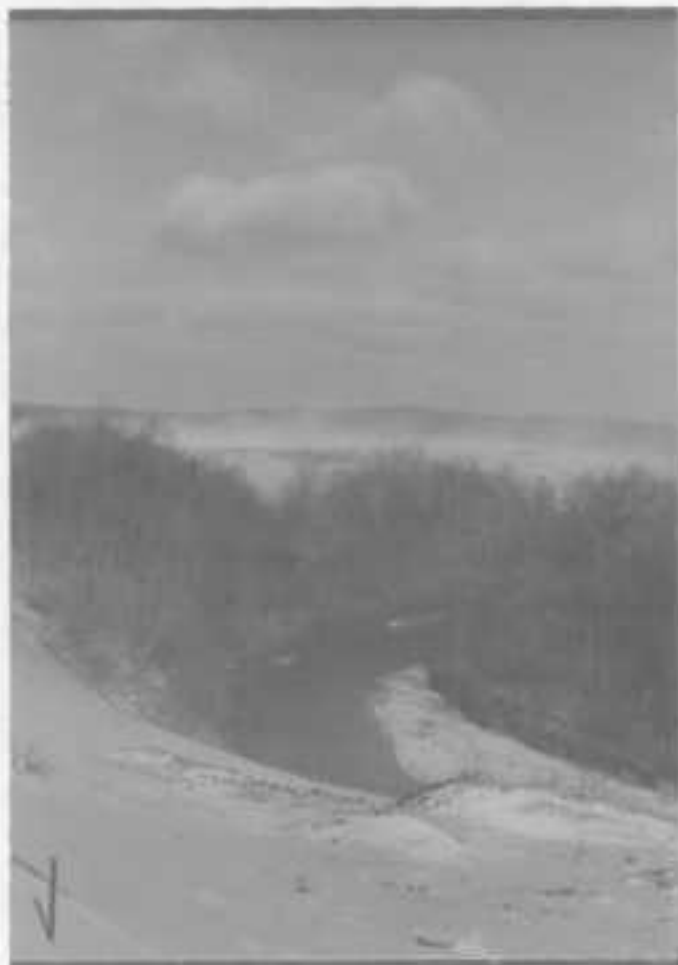
No.: C-1

Subject Big River with mine tailing dust
rising from the pile.

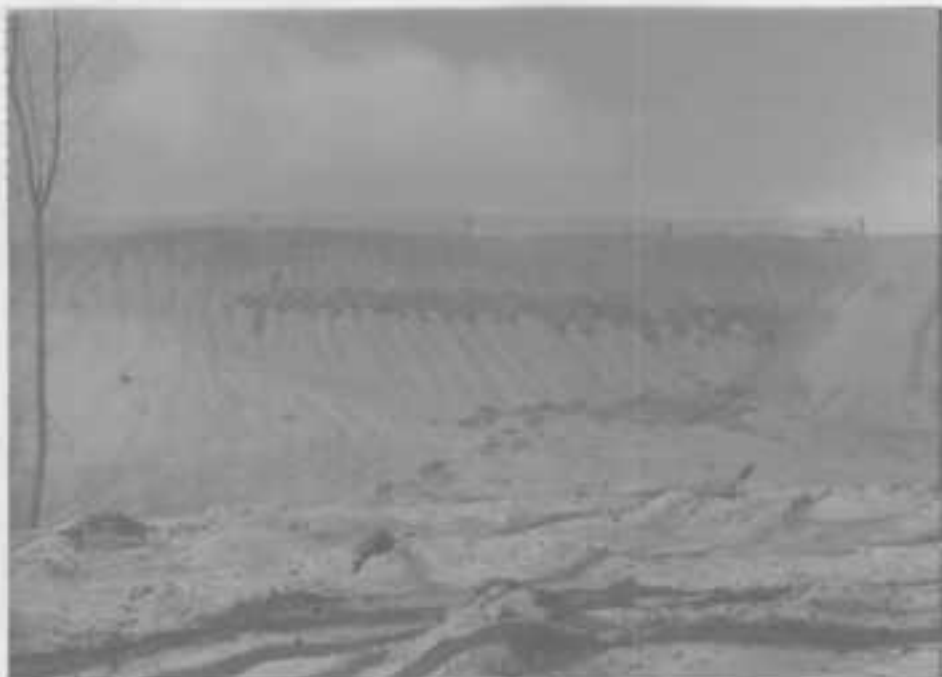
No. C-4

The latest activity was in September and October 1987 when some 20,000 feet of wind fencing was installed on the upper portion of the tailings area. During the FIT reconnaissance it was noted that much of this fencing was damaged or blown down due to a recent storm. Reconstruction of the fencing, as well as reinforcement, are planned. It was obvious that the wind fencing was controlling some movement of the sand-like material, but it is ineffective during stronger winds (Photos C-4 and C-5) (Ref 8).

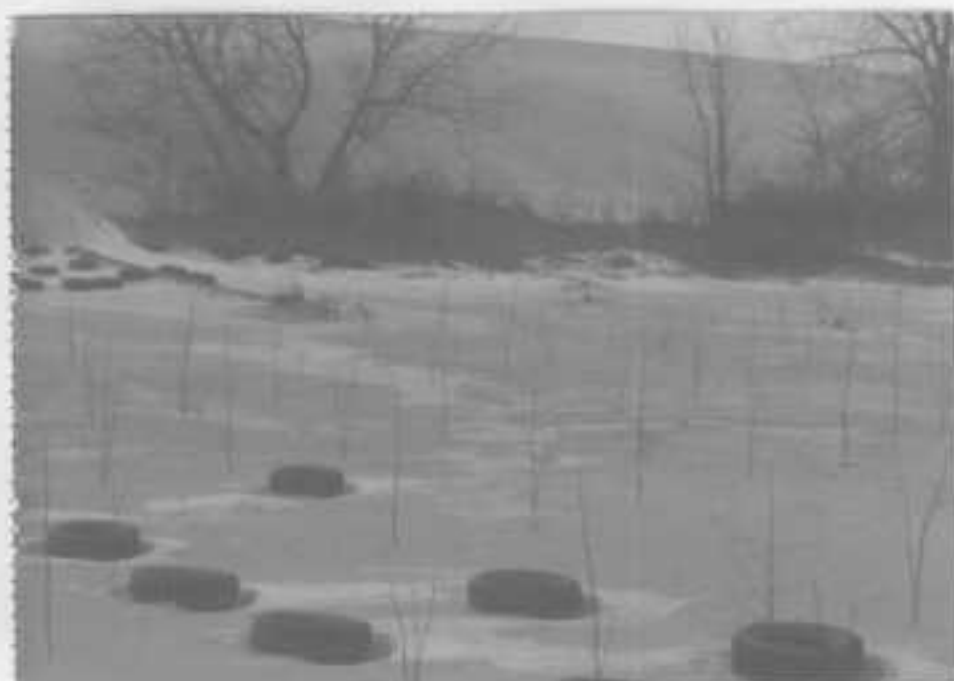
No.: C-8

In April 1983 two small gaps, designated Gaps G and H were formed when unusually heavy rainfall overtopped the retaining berm (Photo C-8) The gaps were filled and a 22-inch steel pipe drainage structure was placed in each In October 1984, 1,500 feet of fence was placed along the base of the chat pile and the area north of the fence was seeded, fertilized, and covered with straw mulch This fence was built to reinforce a dune formed by a wind fence placed in 1980

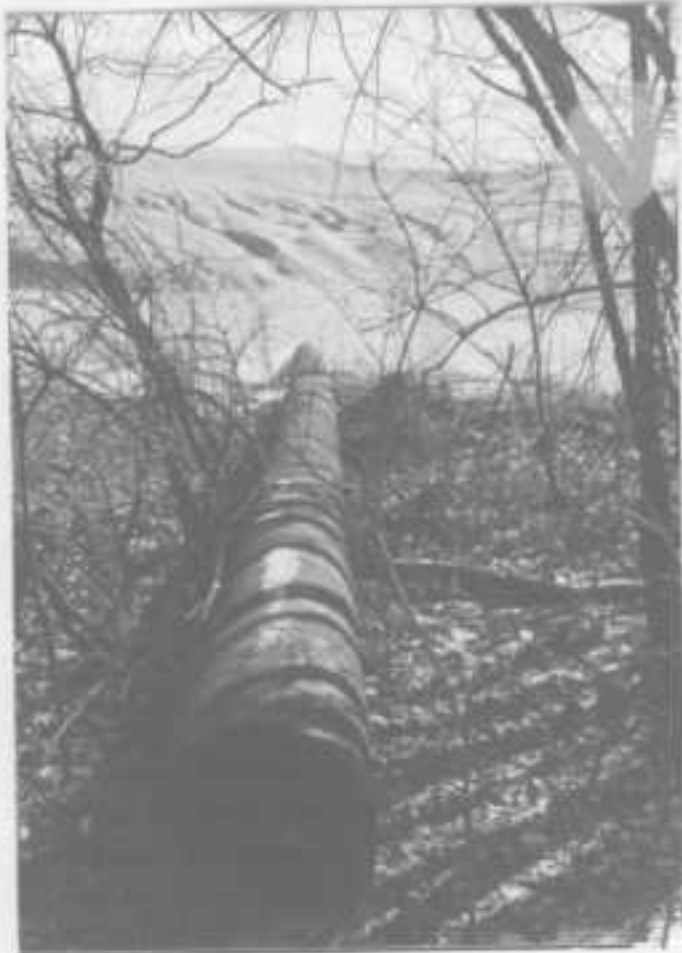
No.: C-11

Subject Gap "I" drainage pipe from
Big River.

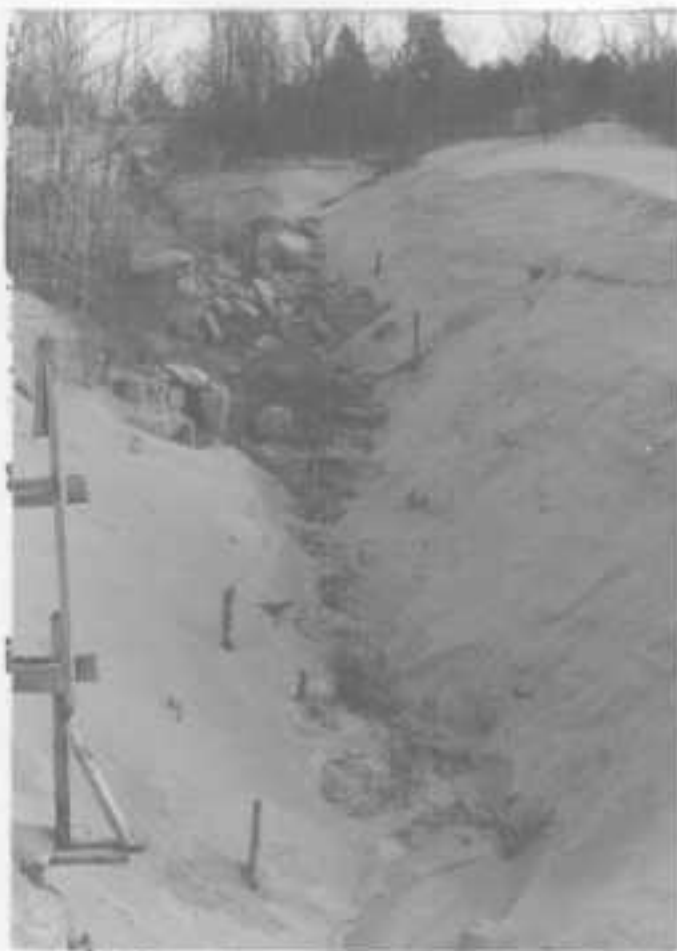
No.: C-15

In April 1985 Gap "I" was formed when heavy rainfall topped the retaining berm. The gap was filled and a 22-inch steep pipe drainage structure was established. At the same time, 2,000 feet of snow fence was placed in the area of the break to build up the retaining berm with wind-blown material. The open channel spillway cut that drains the pond area was deepened and a diversion ditch was cut across natural ground to keep water from flowing into the Gap "I" area (Photo C-10 and C-11). A diversion dike was built through natural ground so that water diverted by the landfill operations would not flow into Gap "E" (Photos C-15, C-16 and C-17).
